**AIRPROX REPORT No 2022084**

Date: 18 May 2022 Time: ~1145Z Position: 5044N 00140W Location: Barton on Sea

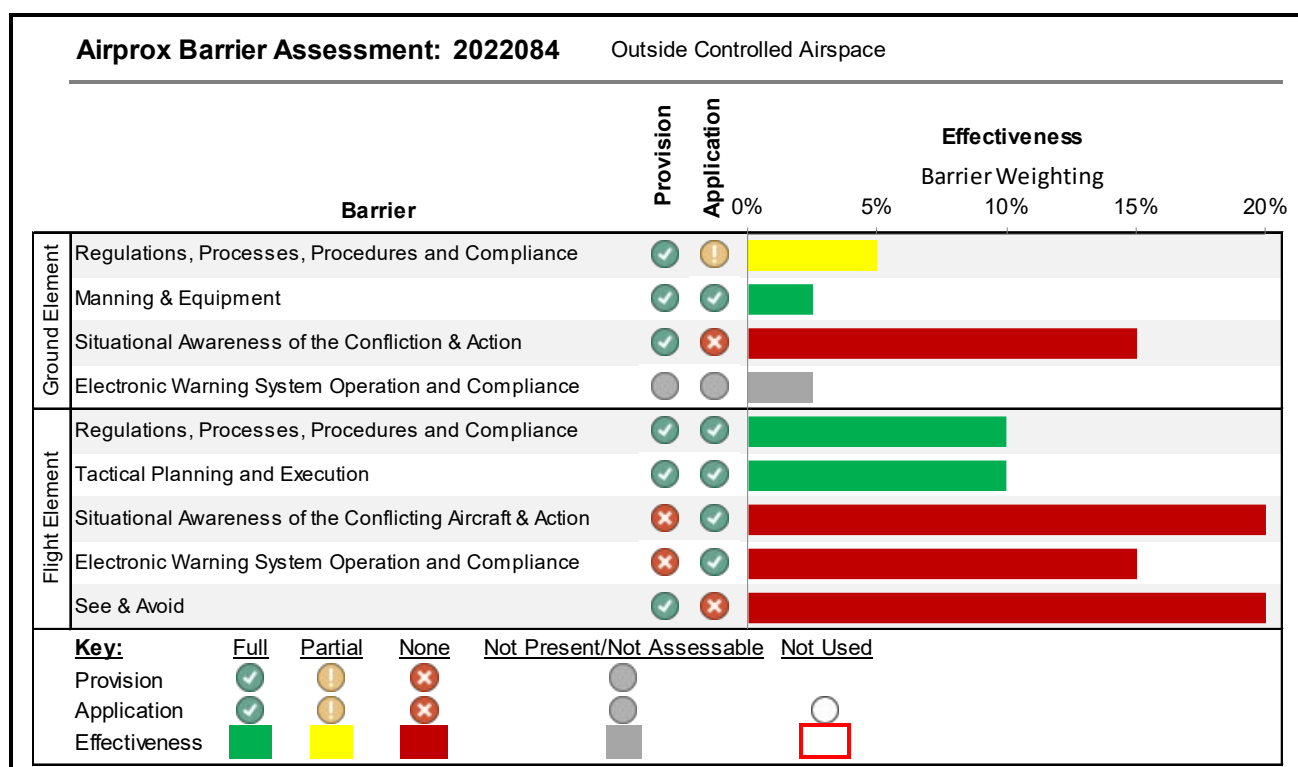
**Electronic Warning System Operation and Compliance** were assessed as **ineffective** because the paragliders were not EC equipped and could not alert the Wildcat TCAS.

**See and Avoid** were assessed as **ineffective** because the Board felt that the Wildcat pilot flew close enough to result in a situation where safety was much reduced.

<sup>2</sup> The UK Airprox Board scheme for assessing the Availability, Functionality and Effectiveness of safety barriers can be found on the [UKAB Website](#).
